ONE STEP FORWARDS...

We sort out the last few bodywork snags and trim the roof edge. Oh, and we need some more paint

Project Traveller Pt. 16

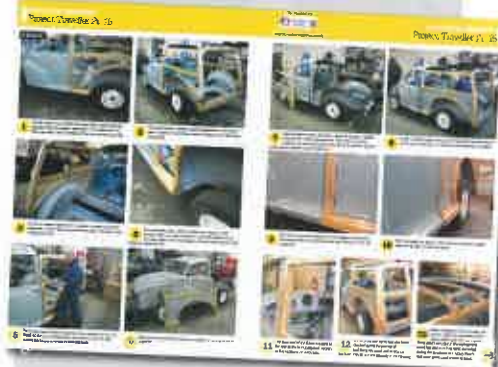
Last month...

We assembled the timber for the last time - and were grateful for the expertise of Charles Ware's team for the way they quickly made the roof fit properly.

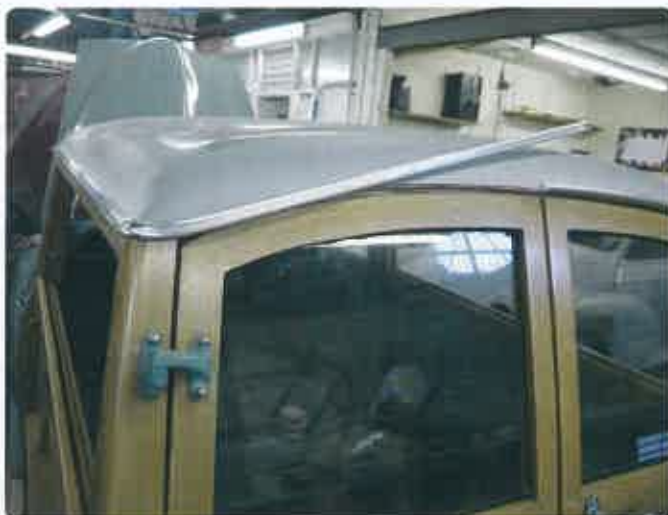
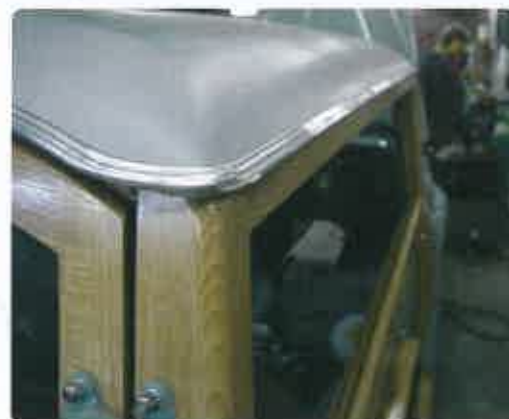
1 If you're not familiar with Minors and the Traveller in particular, then you won't know that the aluminium roof panel is attached to the rear bodywork timber with nails. The aluminium drip rail is also held in place under the nails.

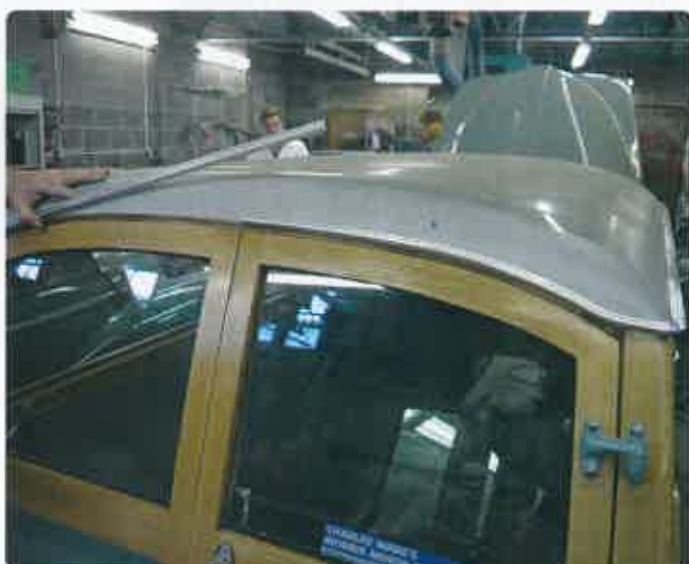
2 The nails securing the roof panel to the wooden frame are concealed by a separate moulding that sits inside the drip rail.

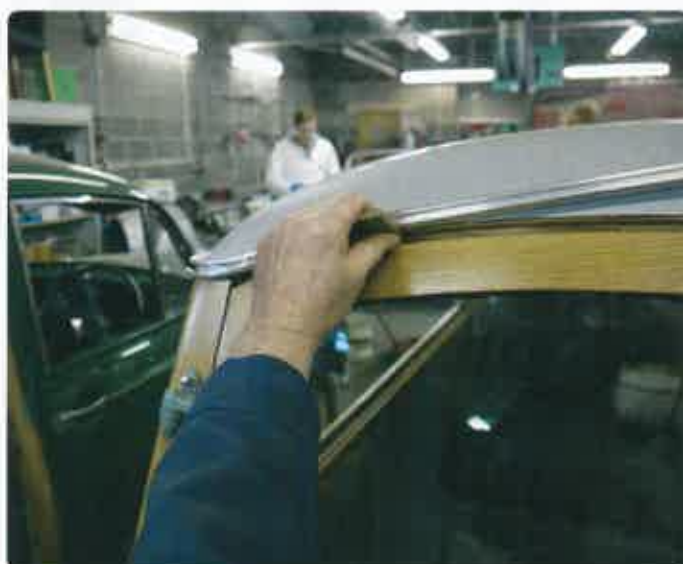
3 It might sound easy but the skill comes in forming the aluminium drip rail and its moulding around the corners of the roof without creating unsightly kinks.

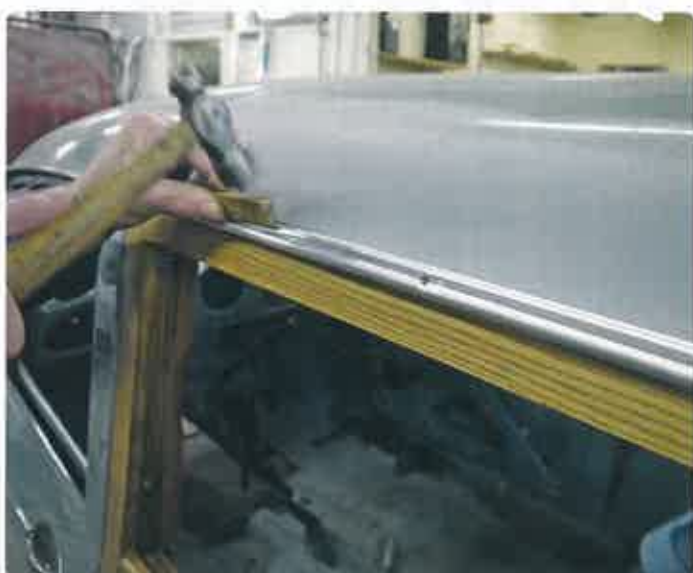
4 Here Neil takes his time by using wooden packing pieces to avoid directly hammering the delicate aluminium trims while coaxing the drip rail around the sharp corners of the roof.

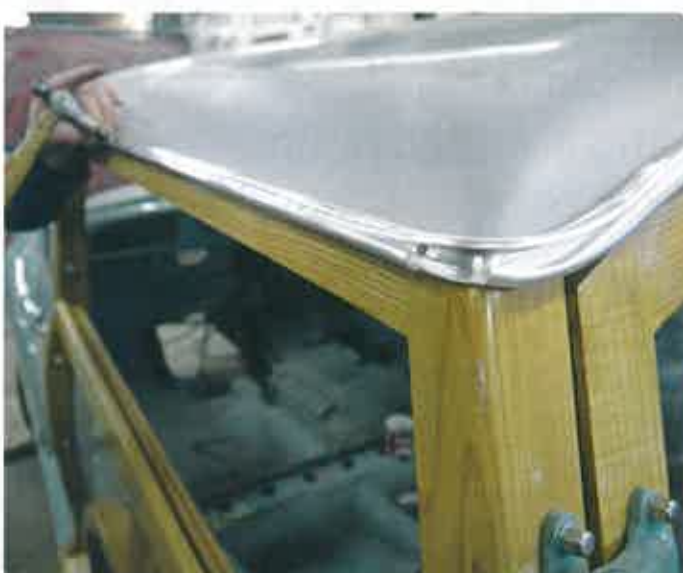
5 The moulding covering the nail heads is a wedge fit inside the drip rail and is gently tapped home using a piece of scrap wood.

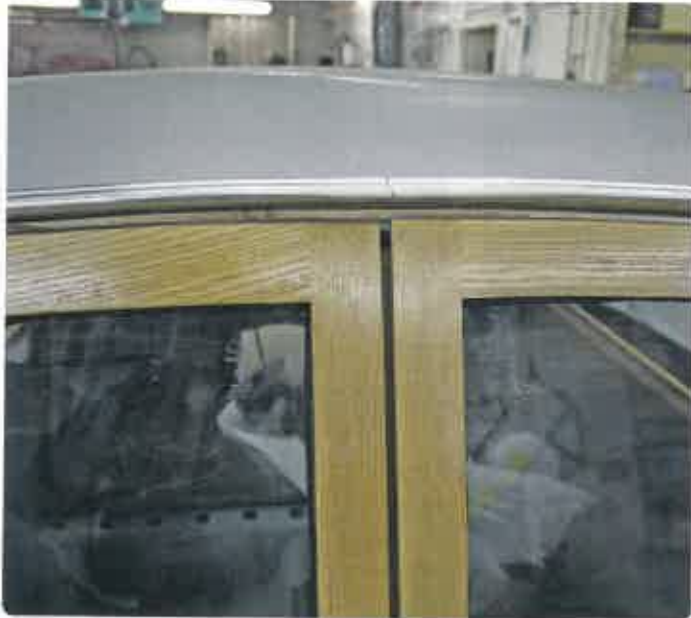
6 Like the drip rail itself, the infill moulding has to be neatly worked around the rear corners.

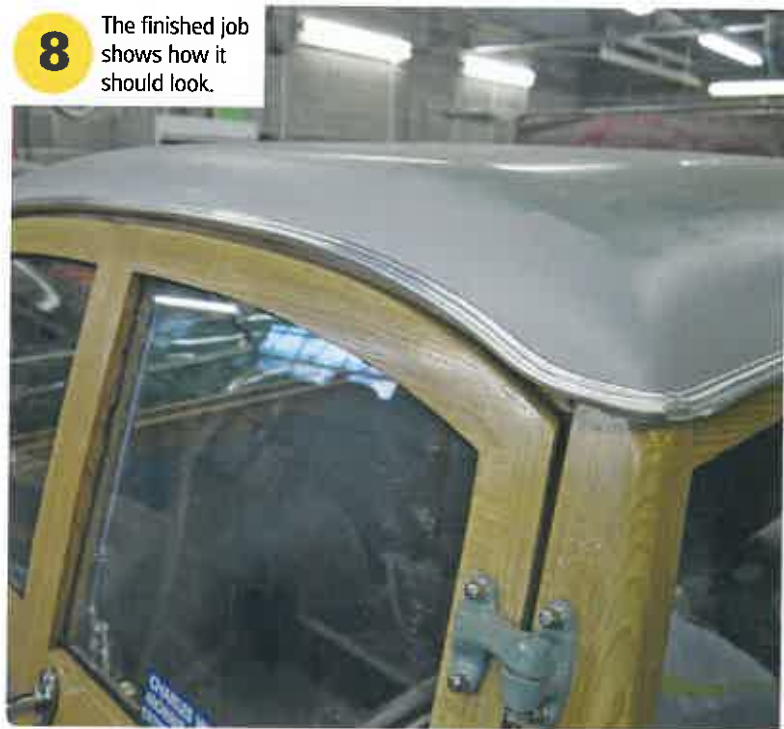
7 The mouldings are fitted as two separate pieces, with the join above the rear doors. Attention to detail here sees the join end up dead in the centre and neatly aligned.

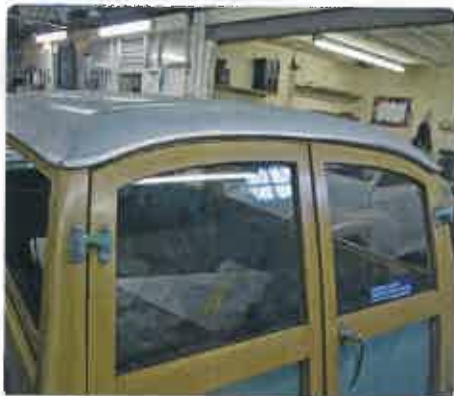
8 The finished job shows how it should look.

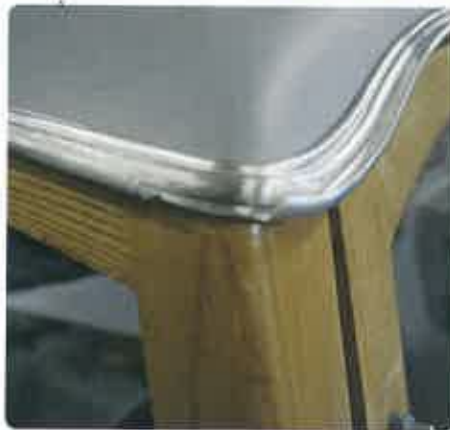
9 The roof panel really shouldn't have been painted before being fixed in place and as you can see, the edges are now in primer after the roof was adjusted to fit properly last month.

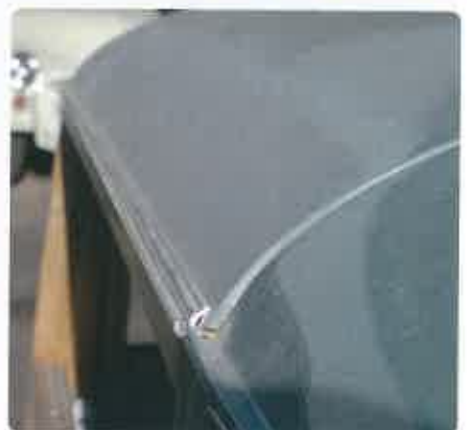
10 The drip rail and moulding covering the nail heads should be in body colour, so will be painted when the roof is repainted.

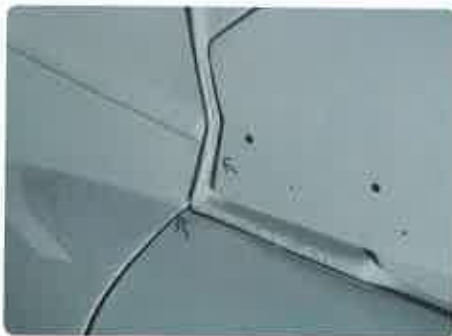
11 As well as meeting neatly above the rear doors, the mouldings need to be aligned with the drip rail on the front bodywork section.

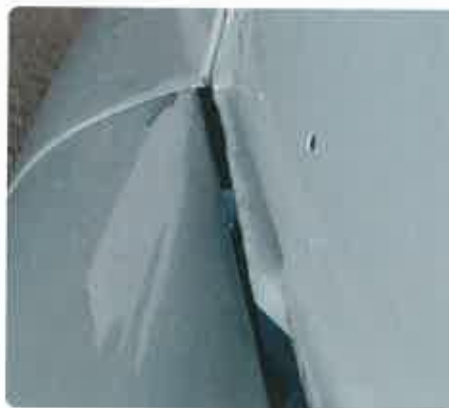
12 Elsewhere, getting the rest of the bodywork to fit nicely has meant a few compromises. The Charles Ware team weren't happy with the fit of our driver's door, and that meant dressing the A-pillar area forwards slightly. The door and wing now cooperate nicely but again the paintwork needs touching in – another reason not to send a car for paint until every last panel has been checked for fit.

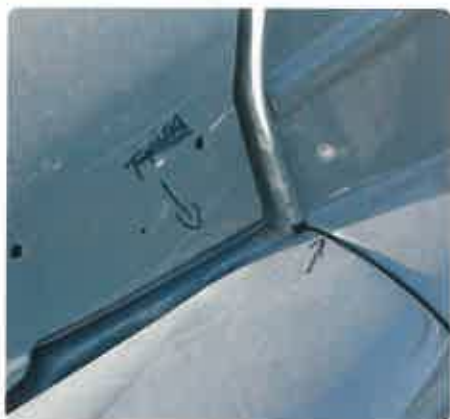
14 The solution is to fill the gap with seam sealer and this shot of the same area on another Minor wing shows how this area should look after it has been correctly filled and aligned.

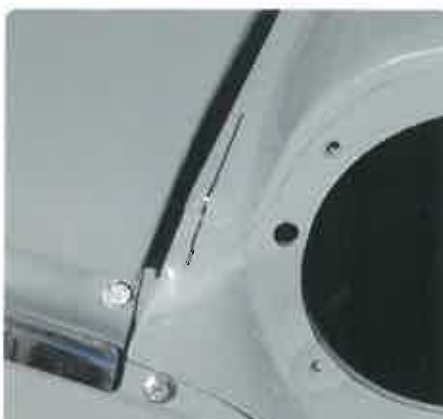
15 We've got a similar problem on the nearside front wing on our Minor but Charles Ware's experienced bodyshop staff quickly sorted this side out without too much major surgery.

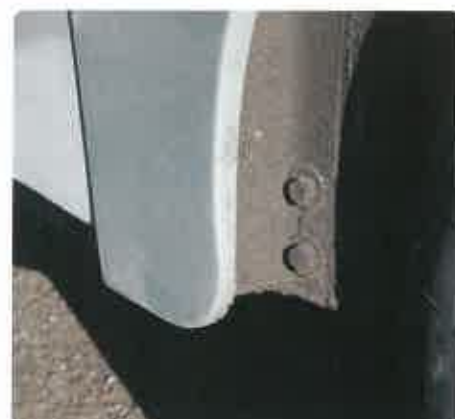
16 The front edge of the nearside wing isn't too neatly finished. Later Minors had this visible seam where early cars were lead loaded, but the angle is generally more precise than this.

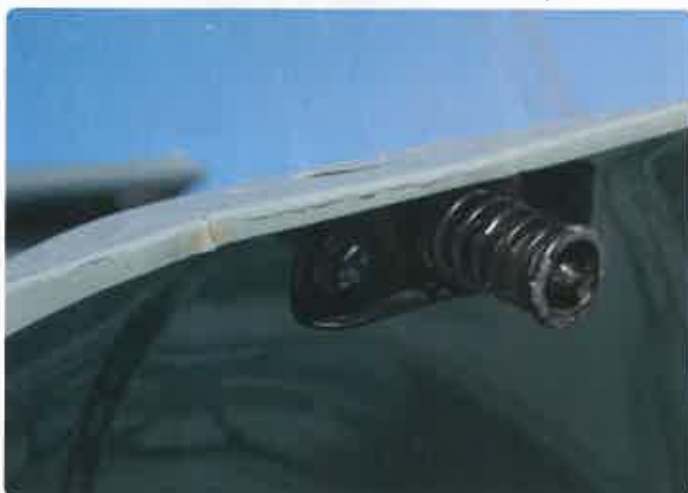
17 Here's a genuine wing and you can see the narrower flange at the rear corner. This is an instant way to identify it – the pattern wings have a visibly bigger return here.
